ELGESETER BRIDGE IN TRONDHEIM DAMAGED BY ALKALI SILICA REACTION: MICROSCOPY, EXPANSION AND RELATIVE HUMIDITY MEASUREMENTS, TREATMENT WITH MONO SILANES AND REPAIR

Viggo Jensen, *Norwegian Concrete and Aggregate Laboratory Ltd, 7018 Trondheim, Norway*; viggo.jensen@nbt.no

Abstract

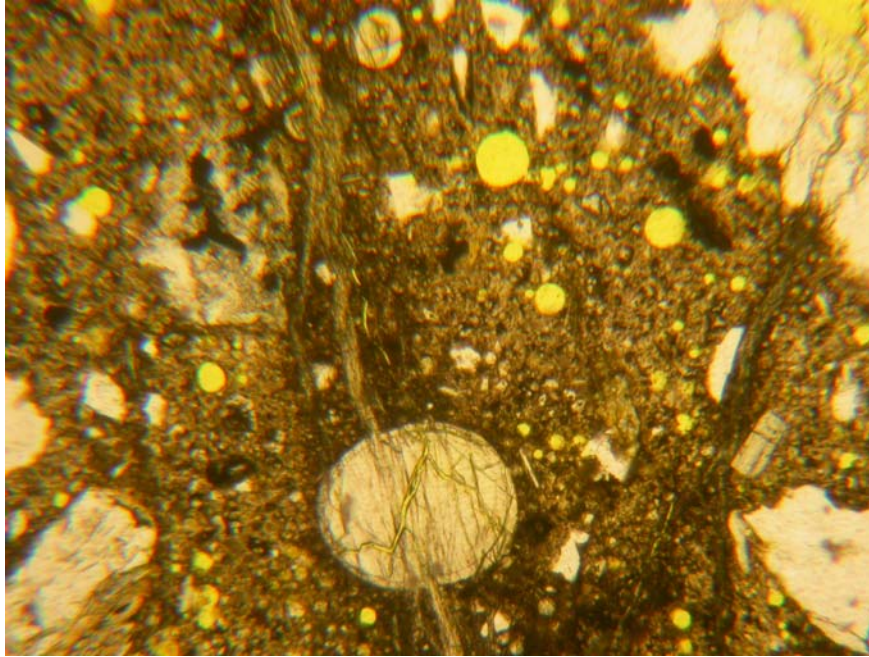
White gel precipitations in air voids and cracks, dark rims around coarse aggregates and cracked aggregates were observed in all the cores, observations which suggest occurrence of ASR. The laboratory investigation revealed that deleterious ASR occurred in all the cores. Therefore, it is most likely that ASR causes the observed cracking and expansions. Figure 6 shows reaction products in an air void and cracks in the cement paste (thin sections).

Figure 6: gel precipitation in an air void and cracks and occurrence of many small air voids (yellow) in the cement paste. Plane polarized light. Length of photo is 2 mm.

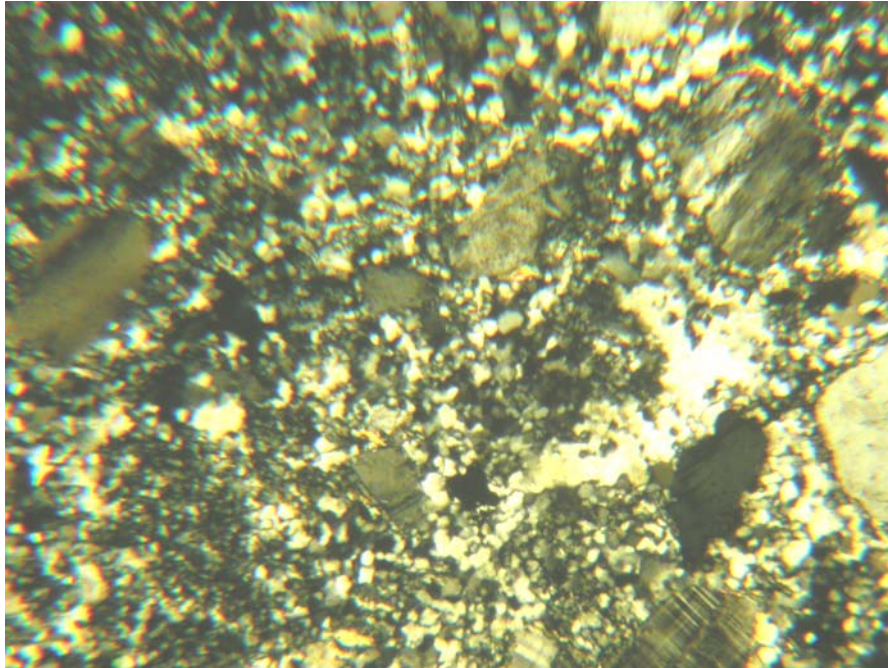
Figure 7 shows micro texture of mylonite where the precursor rock is probably sandstone. Only feldspar has survived the process of cataclasis.

Figure 7: micro texture of mylonite photographed in polarizing light. Length of photo is 2 mm.

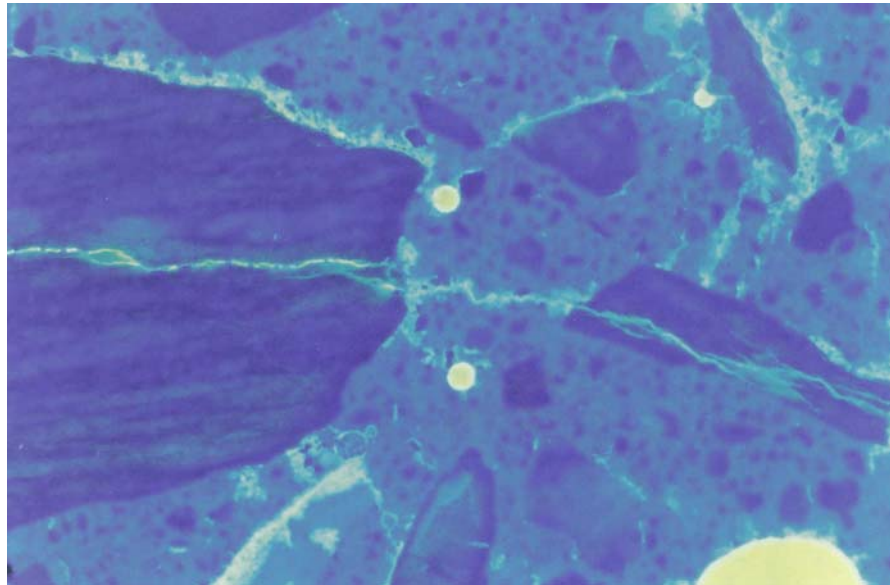
Table 3 includes results from a classification system by Jensen [3], namely “% cracked aggregates” and “cracks in paste”. The results are obtained by counting aggregates containing cracks and aggregates where cracks runs into the cement paste (significant for ASR) as well as number of cracks in the cement paste. This on fluorescent impregnated polished half cores sawed along the length axe and observed in UV-light.

Figure 8: fluorescence impregnated concrete in UV light. Cracks occur in aggregates and in the paste

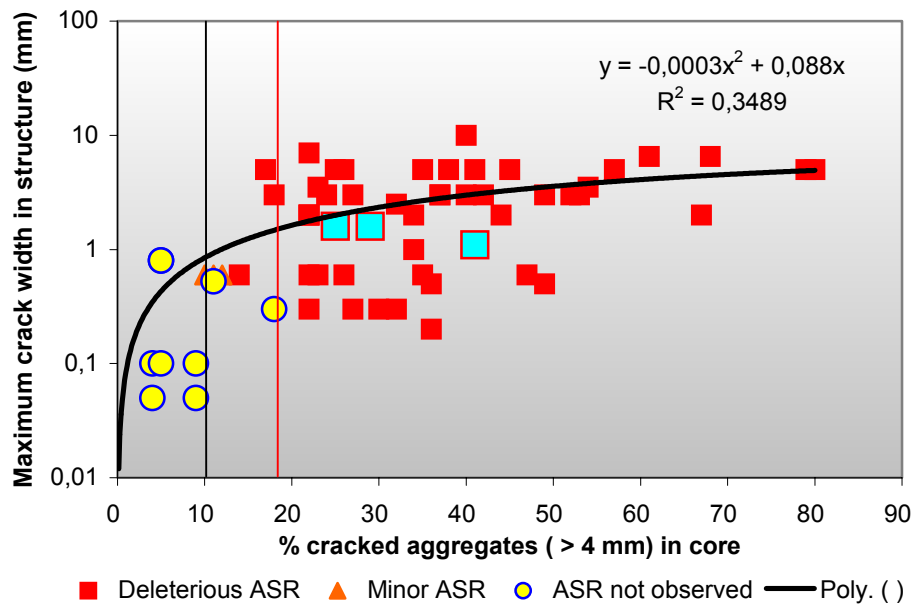
Figure 9 shows % cracked aggregates in cores related to maximum crack width in structure [3]. The plot is based on 83 cores from structures in Southern Norway. The cores were ranked as “deleterious ASR”, 52 cores, “minor reaction”, 7 cores, and “ASR not observed”, 24 cores. ASR was documented by examination of 112 thin sections. Elgeseter bridge is shown with blue squares in figure 9.

Figure 9: % cracked aggregates in cores related to maximum crack width in the structure. Results from Elgeseter bridge are shown as blue squares.

Figure 9 is a plot of cracks in structures and cracks in cores. Because of the uncertainties (counting in cores and measurements of maximum crack width in structure) the correlation is rather low but real. Moreover, a “gray zone area” between 10% and 18 % cracked aggregates (see figure 9) exists where “deleterious ASR”, minor ASR and “ASR not observed” plot together. From this investigation it can be suggested that less than 10% “cracked” aggregates is the limit to distinguish between concretes suffering from ASR or not.

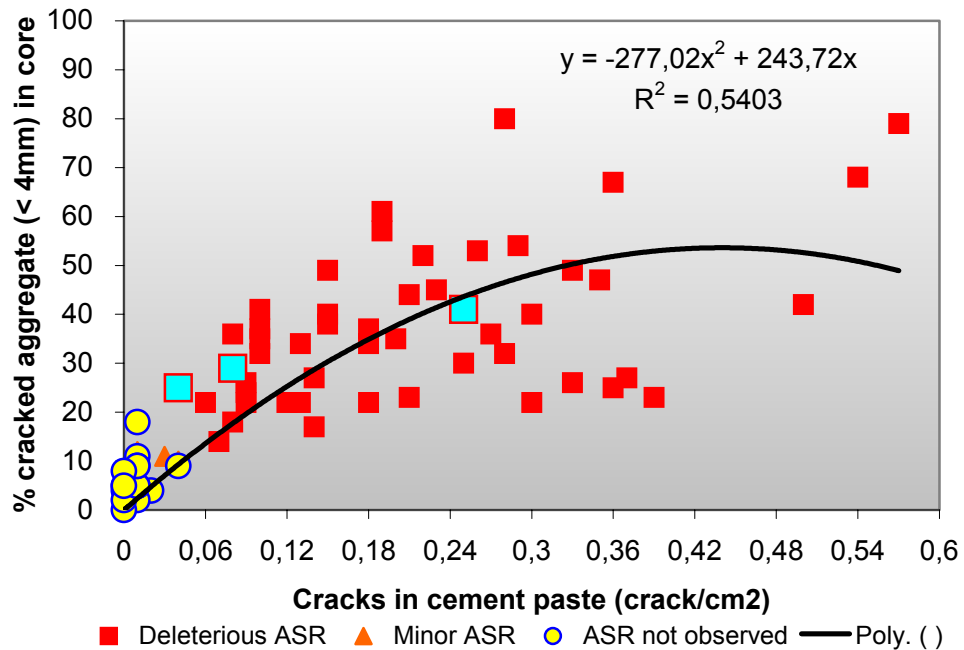
Figure 10: % cracked aggregates and cracks in cement paste in cores. Results from Elgeseter bridge are shown as blue squares.

Figure 10 shows % cracked aggregates and cracks in cement paste from the same 83 cores. Results from Elgeseter bridge are marked with blue squares. The figure shows an acceptable correlation between “% cracked aggregates” and “cracks in paste”. Therefore, it is likely that ASR has caused most of the cracks occurring in the paste. Very few cracks occur in samples where ASR not has been diagnosed.

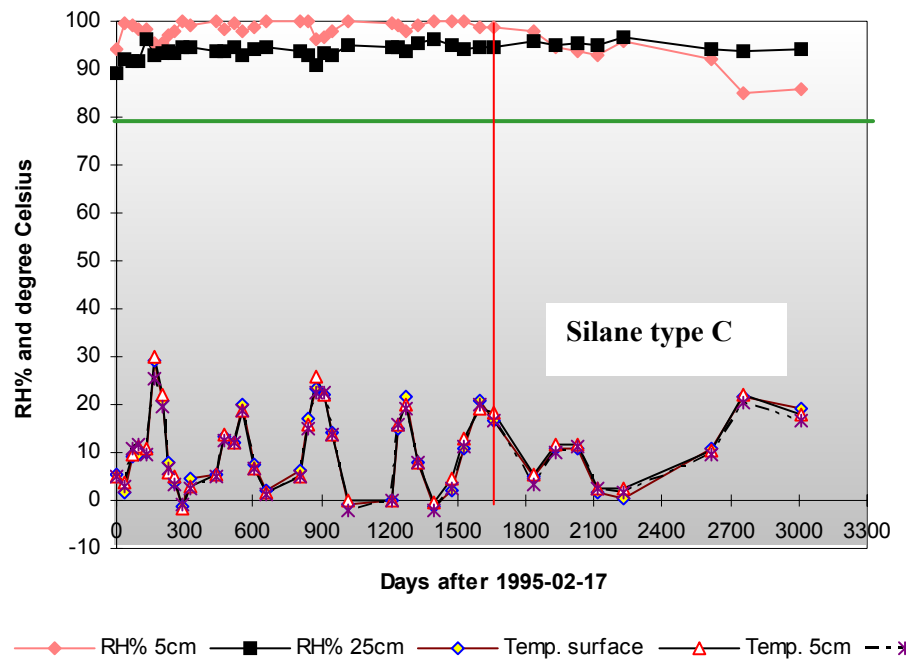
Figure 12 shows location 8 where relative humidity has been measured since 1995. After 1700 days silane type C was applied the columns, Jensen [10]. Note that the relative humidity 5 cm from the surface hereafter reduces and that relative humidity is not influenced by temperature fluctuations.

Figure 12: measurement of relative humidity and temperature at location 8. After 1700 days silane type C was applied the concrete (vertical line)

Measurements have shown that relative humidity in the concrete varies from 100% to 87% (before impregnation with silanes). Moreover profiles have shown that the relative humidity is significantly higher on western faces relative to eastern faces of columns. Expansion of cracks varies from 0.04 mm to 0.15 mm yearly. Expansion results suggest that the rate is reduced the last few years.

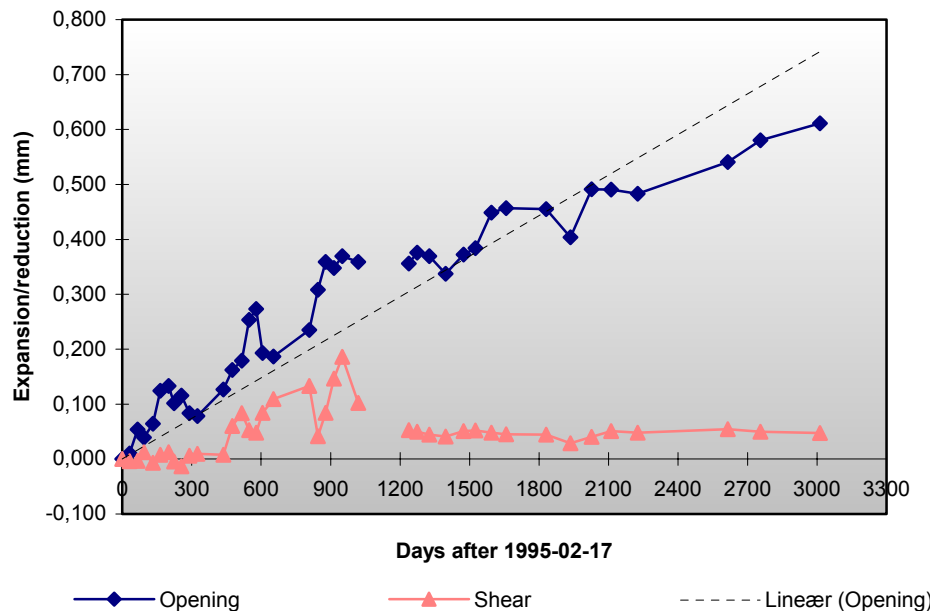
Figure 13: measurement of expansion of crack, location 3

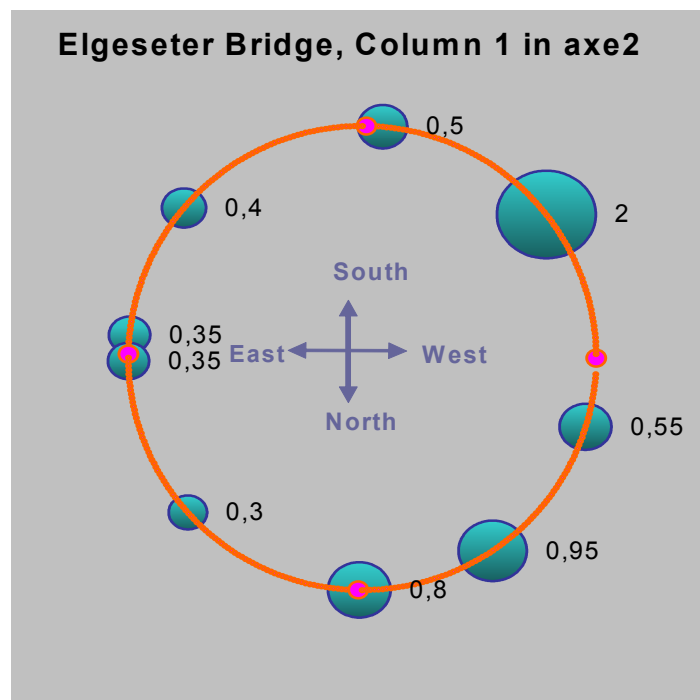
Figure 14 shows crack distribution in column 1 in axe 2 as a “bird eye view”.

Figure 14: crack distribution in column 1 in axe 2. Filled circles are individual cracks with different sizes and number is crack width in mm. Bird eye view.

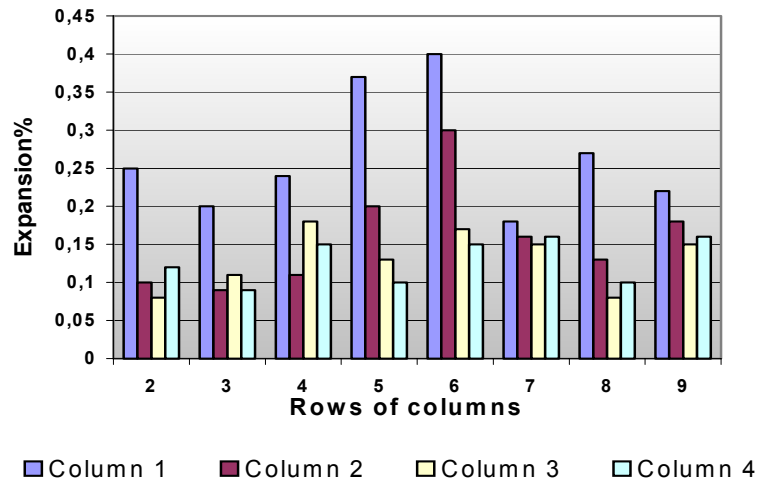
Figure 15 shows expansion from all the columns in Elgeseter bridge. Note that the highest expansions occur in columns located most westerly (column 1) and in the middle of the river.

Figure 15: distribution of expansions in columns, Elgeseter bridge

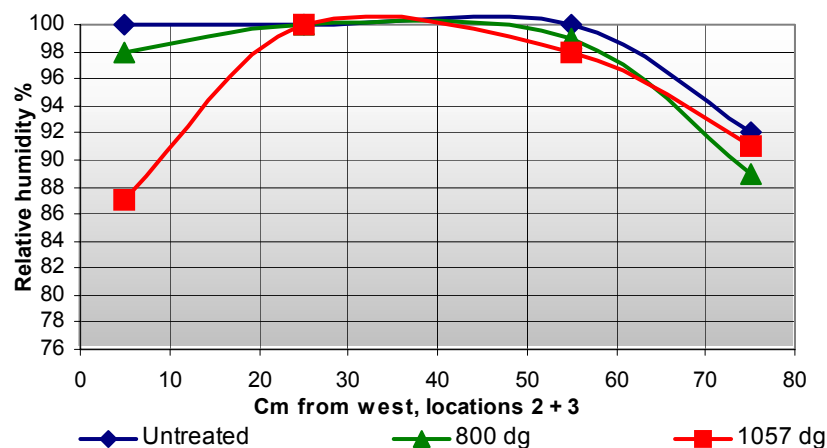
Figure 16: humidity profiles through column 1 axe 2 about 1.5 m over ground level. Measurement before impregnation (untreated), 800 days and 1057 days respectively after silane A was applied.

In all silane impregnated columns relative humidity has been reduced significant 5 cm from the surface. In the “center” of the column impregnated with silane type C (55 cm from Western face) relative humidity has been slightly reduced. Only time will confirm if the relative humidity also reduces in the middle of the columns.

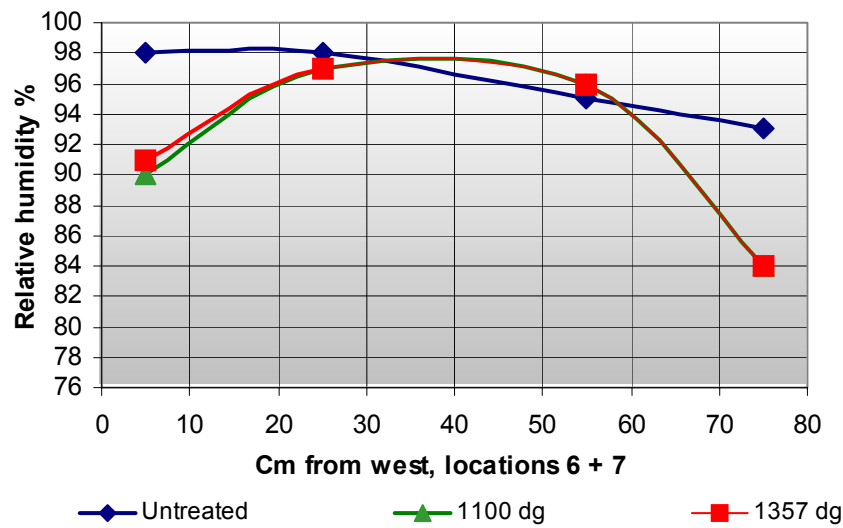
Figure 17: humidity profiles through column 1 axe 9 about 1.5 m over ground level measurements before impregnation (untreated), 1100 days and 1357 days respectively after silane B was applied.

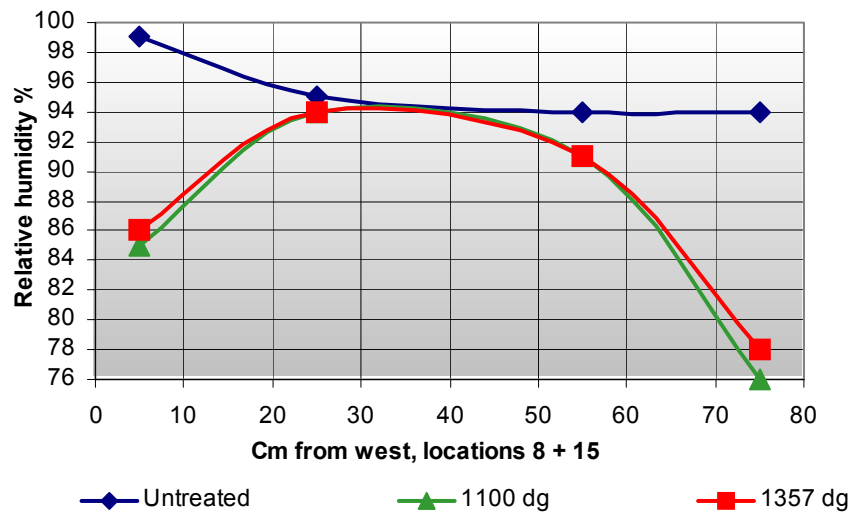
Figure 18: humidity profiles through column 3 axe 9 about 1.5 m over ground level. Measurement before impregnation (untreated), 1100 days and 1357 days respectively after silane C was applied.

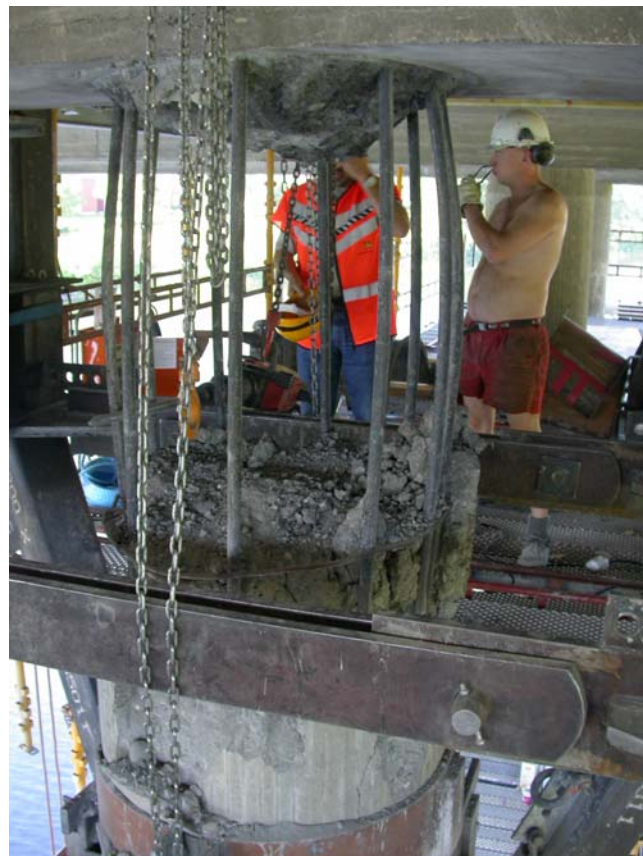
Figure 19 shows the upper part of column 3 in axe 7 where the concrete has been removed. Note that reinforcement is bent due to impact from the explosion, Jensen [14].

Figure 19: upper part of column 3 in axe 7 where the concrete has been removed.

In 2003 the Road Directorate rehabilitated all the northern columns in axe 7, 8 and 9 on Elgeseter bridge. The author has not been involved in this work or the decision behind it. Therefore, the rehabilitation work only is briefly described in the following. The major repair work was to move columns back to a vertical position. A special steel construction was made to support the beam before demolishing the upper 1 meter of the column by “micro blasting”, a Danish technique. Hereafter the reinforcement was cut and the column moved back to vertical position. Reinforcement was then welded to the beam and the upper part of the column remolded with concrete.

Because the rehabilitation work caused some esthetical damages to the columns (and to “hide” cracks) an elastic cement latex surface protection product was applied all rehabilitated columns. Unfortunately the two columns impregnated with silane type B and C were surface protected too. However, measurement of relative humidity and expansion of cracks is planned to continue and will include two new columns applied elastic cement latex..
