Relative Humidity Measured by Wooden Stick Method in Concrete Structures: Long Term Measurements and Reduction of Humidity by Surface Treatment.

By Viggo Jensen*

Key words: concrete, Alkali Aggregate Reaction, relative humidity, surface treatment, silane, wooden stick method

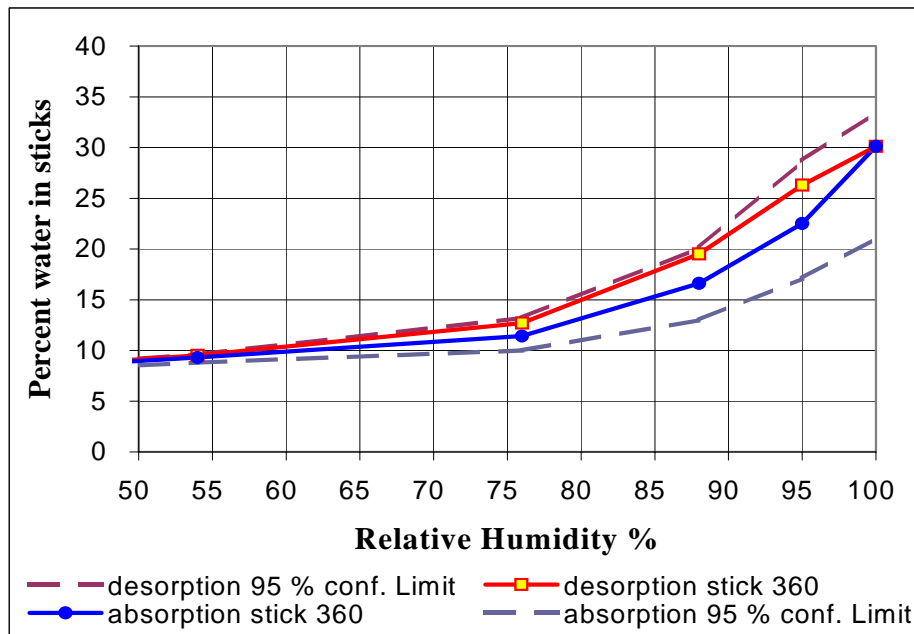
Fig. 1. Calibration curves for wooden stick no.360 and the 95% confidence interval for 112 wooden sticks shown with broken lines.

The wooden sticks of the species Ramin used in the Norwegian projects, have a diameter of 12 mm and are 45 mm long. Other types of wood might be used but documentation on accuracy and long term performance test should then be carried out. For each wooden stick, calibration curves of adsorption and desorption are made. Experience has shown that calibration curves vary between wooden sticks, sometimes significantly. Fig. 1 shows an example of adsorption and desorption curves for one wooden stick (no.360) and the 95% confidence interval calculated from 112 wooden sticks (1, 7, 8). It can be seen that the accuracy of measurements is improved by the use of individual calibration curves rather than by one standardized curve, which is the case in the UK and Denmark. The difference between relative humidity from the desorption curve and the adsorption curve can be used as a measure of the accuracy. Note the steeper inclination at higher relative humidity, which means, that the sensitivity is improved with higher relative humidity, see Fig. 1. This is opposite to all other commercial humidity apparatus where measurement of relative humidity higher than 98% often is uncertain.

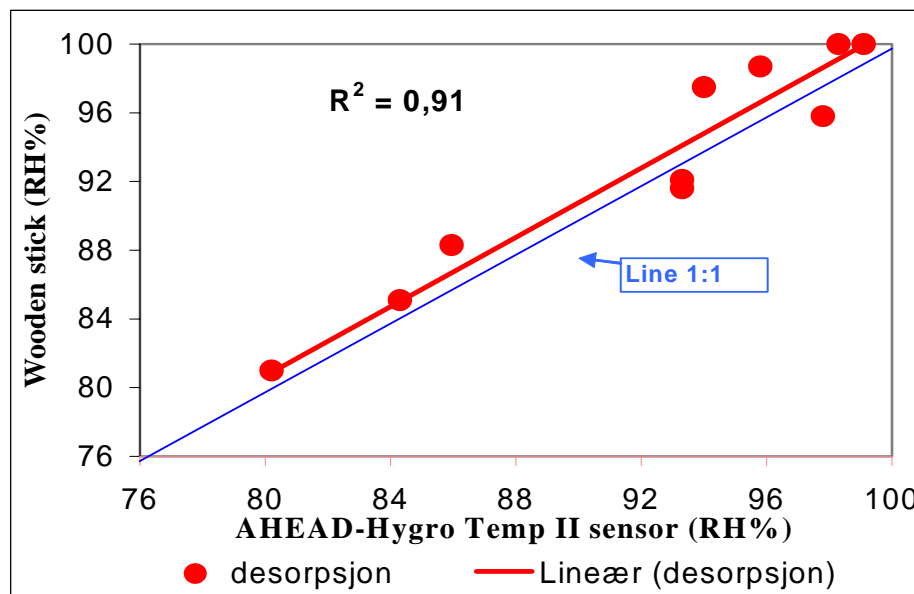
Fig.2. Correlation between wooden sticks by use of the desorption curve and AHEAD hygrotemp II sensors.

To assess the reliability of the wooden stick method, a correlation test between wooden sticks and a commercial type electrical humidity probe was carried out. Wooden sticks, mounted in Elgeseter bridge (Trondheim) were removed after a period of 3 years, then sealed in tight plastic bags, and taken into the laboratory. After the laboratory temperature was reached (20 °C), the measurements on the sticks were carried out (9). The sticks were then put into small tight plastic containers for measurements with the AHEAD hygrotemp II probes (Norwegian commercial equipment). Fig. 2 shows the correlation between the RH determined by the wooden sticks and AHEAD HygroTemp II sensors. Note the acceptable correlation between the two methods and that both methods more or less measure the same RH. Later correlation tests, carried out in 2000 and 2002 on wooden sticks and Humi Guard sensors (Swedish commercial equipment) but now "in situ" also showed acceptable correlation, see Fig. 3. However, Humi Guard sensors obtain lower RH

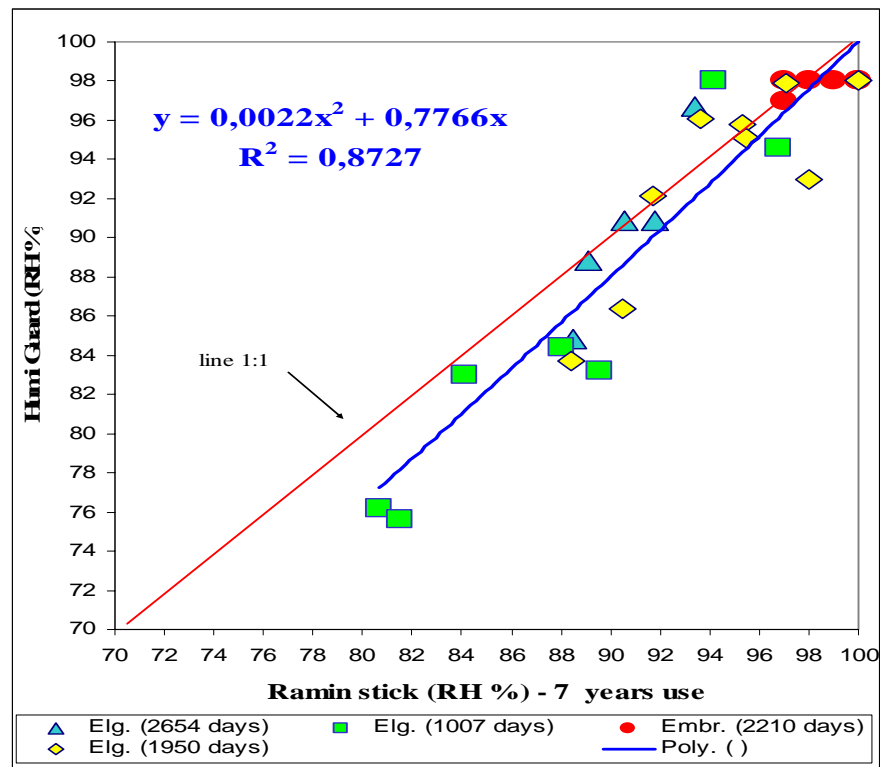
Fig. 3 Correlation between wooden sticks and Humi Guard sensors in-situ. Correlation measurements from Elgeseter bridge and Embretsfoss dam. Some wooden sticks continuous used 7 years.

relatively to wooden sticks in concretes with RH less than about 90%. This was not the case between wooden sticks and AHEAD HygroTemp II sensor. The results indicates that the wooden sticks were still reliable after 7 years use in structures.

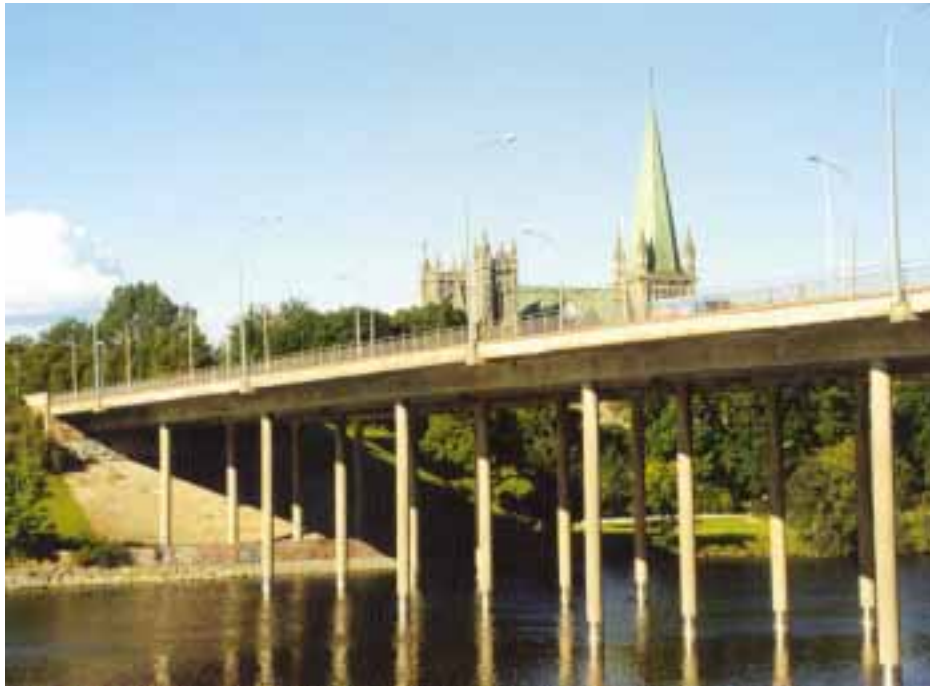
Fig 5. Northern part of Elgeseter Bridge, with the millennium old cathedral “Nidaros Dome” in the background.

Elgeseter bridge was built in 1949-1951 as a continuous 200 m long reinforced concrete bridge supported by 8 bents with 4 columns each having a diameter of 80 cm, see Fig 5. AAR was diagnosed by microstructural analysis in 1990 to be caused by the rock types mylonite, graywacke and argillite¹. In columns, several vertical cracks up to 3-mm width can be followed from ground level to the underside of the supported beams. Some columns also contain map cracking. Inspection and measurement of cracks in columns show more cracking on the western faces compared with eastern faces due to rainwater (eastern faces of columns stay dry when it rains). Measurements have also shown that columns exposed more westerly and located in the middle of the river have more cracks. Cracks are still opening and increase from 0.04 mm to 0.15 mm yearly (9).

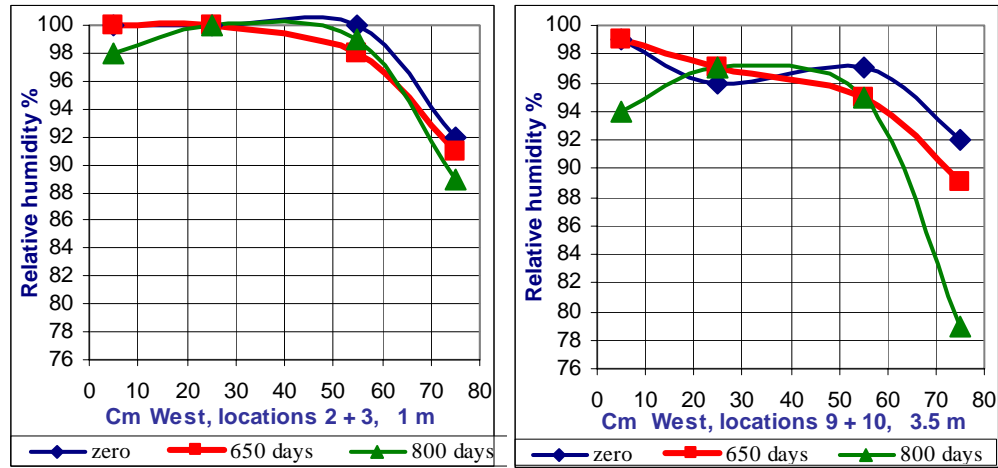
Fig. 7. Humidity profiles West – East, 1.2 meter (left figure) and 3.5 meter (right figure), over ground level. Measurement, before impregnation with silane type A (zero), and measurements 650 days and 800 days after type A was applied.

Results of impregnated columns to date (September 2002) are given in Table 1. Results suggest that treatment with silane apparently reduces the concrete's relative humidity even when columns are massive and AAR is in an advanced stage³. Moreover, one of the products apparently reduces the relative humidity more efficiently compared with the other two products; Fig. 7, 8 and 9.

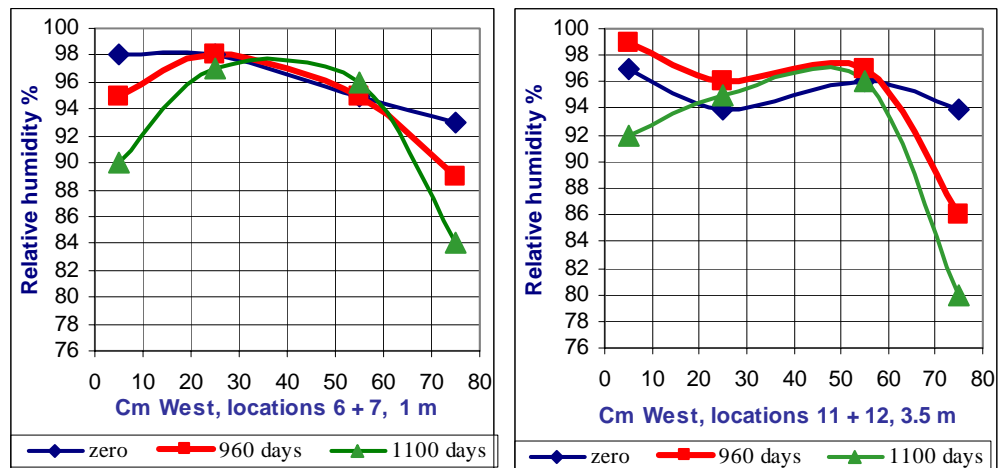
Fig. 8. Humidity profiles West – East, 1.2 meter (left figure) and 3.5 meter (right figure) over ground level. Measurement, before impregnation with silane type B (zero), and measurements 960 days and 1100 days after type B was applied.

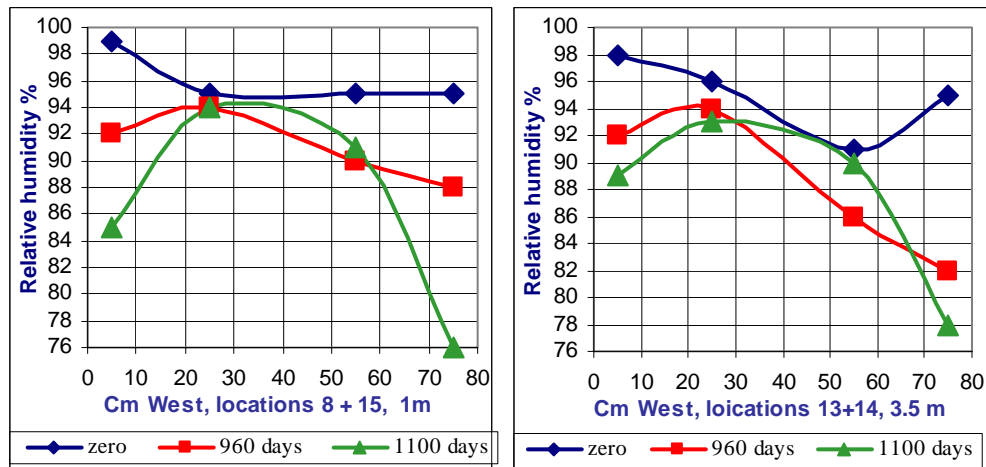
Fig. 9.. Humidity profiles West – East, 1.2 meter (left figure) and 3.5 meter (right figure) over ground level. Measurement, before impregnation with silane type C (zero), and measurements 960 days and 1100 days after type C was applied.

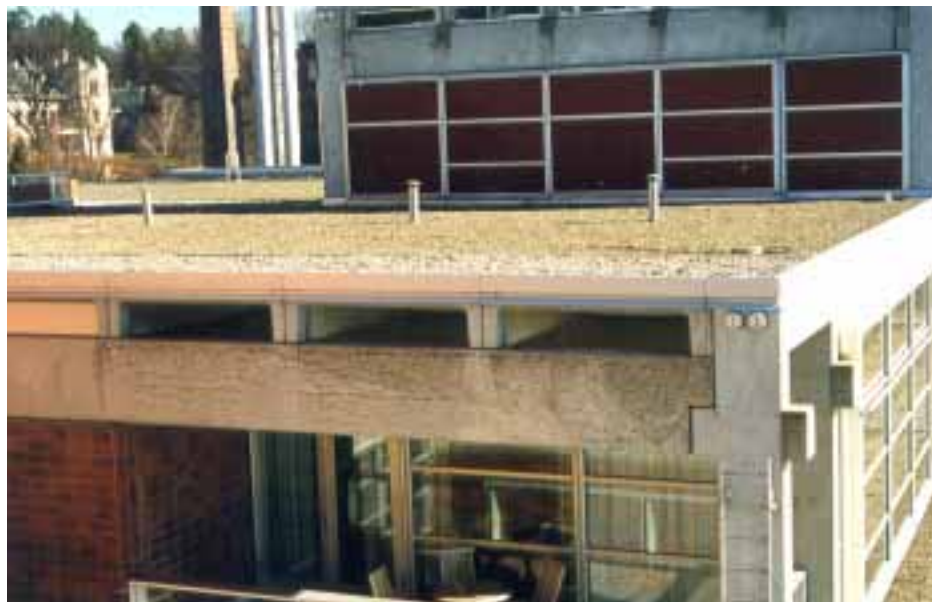
Fig. 10 The Norwegian Veritas House with prefabricated beams and columns. Note the cracked beams in the front

The Norwegian Veritas house (DNV) was built during the period 1974 - 1976 using prefabricated columns and beams. The building covers a ground area about 1400 m² with several unit buildings of 3 to 5 storey heights. Today, cracking is observed on the exposed faces of the columns and beams, mostly on the upper faces of the building, see Fig. 10. It is uncertain when cracking first appeared but employees working in the building have indicated that the intensity of cracking has increased during the past few years. In 1996, AAR was diagnosed by microstructural analysis caused by impure limestone (metamarl), sandstone and mylonite⁴. In 1998, twenty measurement locations were mounted on beams and columns on the roof of one of the buildings.

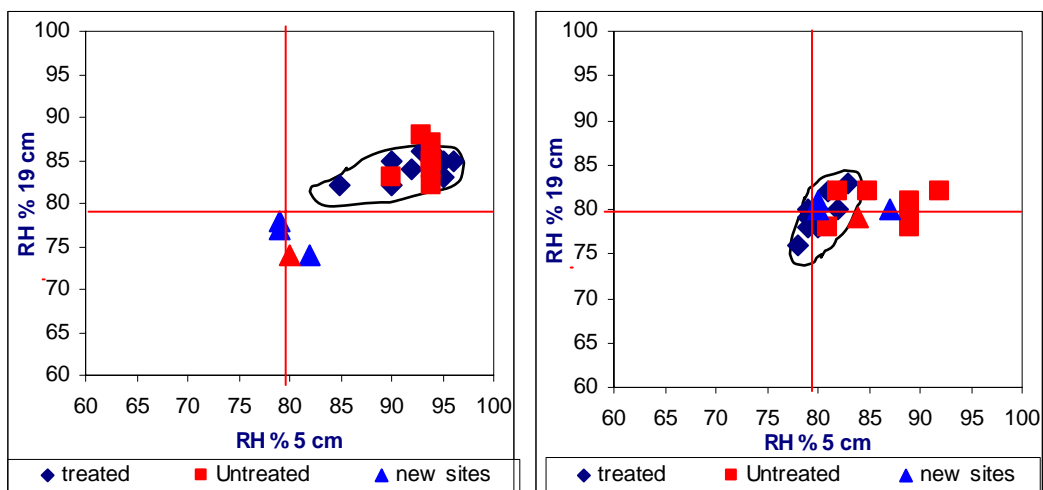
Fig. 12. Distribution of relative humidity, from the start (left figure) and after 1493/1263 days (right figure). Note that treated locations (enclosed by lines) obtain significant reduced RH% after 1493 days.
