## **IN-SITU MEASUREMENT OF RELATIVE HUMIDITY AND EXPANSION OF CRACKS IN STRUCTURES DAMAGED BY AAR**

Viggo Jensen  
Norwegian Research Council (NFR),  
SINTEF Civil and Environmental Engineering, 7465 Trondheim, Norway

### **ABSTRACT**

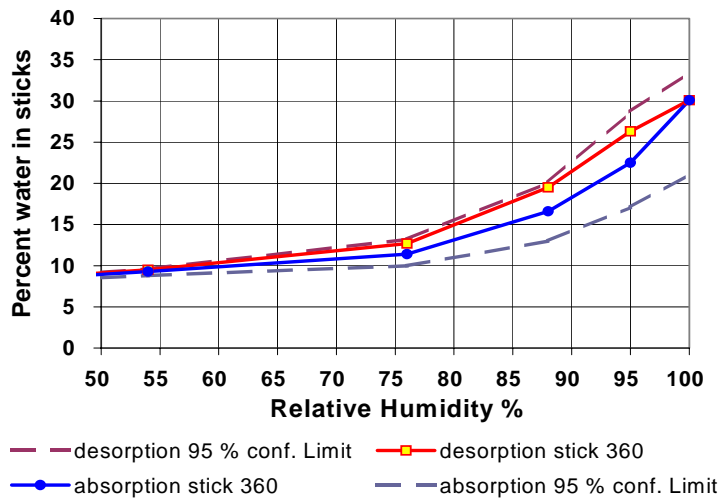
example of the adsorption and desorption curves for one wooden stick (no.360). In the figure the 95% confidence limits of 112 wooden sticks are shown with broken lines (calculated as the average of the adsorption values of 112 sticks - 2 standard deviation, respectively the desorption values + 2 standard deviation). It is easy to see that the precision of measurements is improved by use of individual calibration curves rather than by one standardized curve as used in UK and Denmark. Here an “average” adsorption curve normally has been used. The difference between relative humidity from the desorption curve and the adsorption curve can be used as measure for the uncertainty of the measurement. Note also that the inclinations of curves are higher with higher relative humidity which means the uncertainty is reduced with higher relative humidities. Note that when relative humidity > 70% the precision is about +/- 6% for the 95% confidence interval and about +/- 3% by use of individual curves (stick no. 360).

Fig. 1: Calibration curves for wooden stick no.360. In the figure the 95% confidence limits from 112 wooden stick is shown with broken line

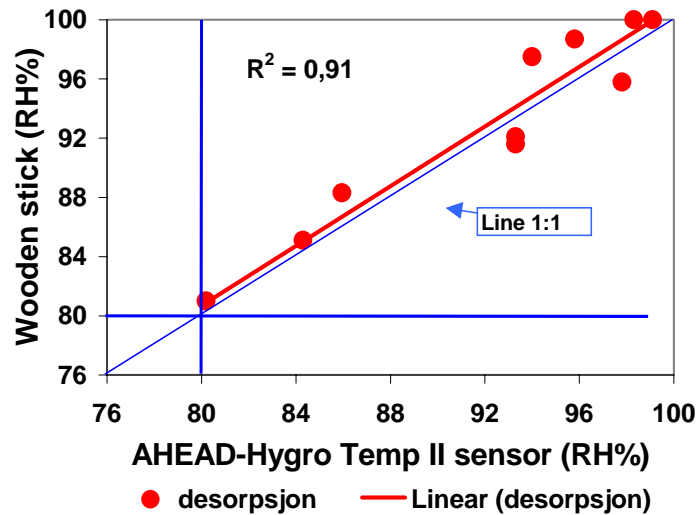
Fig. 2: Correlation between wooden stick with use of the desorption curve and AHEAD hygrotemp II sensors.

Wooden sticks mounted in Elgeseter bridge, Trondheim and frequently measured during a period on 3 years, were sealed in tight plastic bags, and taken in to the laboratory. After laboratory temperature was reached (20 °C) the WS measurements were carried out. The sticks were then put into small tight plastic containers for measurements with the AHEAD hygrotemp II probes. The relative humidity was measured when equilibrium between the wooden stick and air was established. Fig. 2 shows the correlation between the WS – method with use of the desorption curve and AHEAD hygrotemp sensors. Note the acceptable correlation between the two methods. Similar good, but slightly lesser correlation, can be shown by use of adsorption curves.

Relative humidity measurements by wooden sticks are very stable over time and lies in the interval 80% to 100% in structures with AAR, as expected. Comparison test between wooden sticks used for 3 years in a bridge structure and a commercial electrical humidity sensor system (AHEAD hygrotamp II) shows excellent correlation. By use of individual calibration curves valid only for one stick the precision in the interval 70% to 95% relative humidity can be better than +/- 3 %. It can be shown that surfaces exposed to periodically rain obtain higher humidity than leeward surfaces. The existences of humidity profiles in bridge columns and beams/columns in an office building have been demonstrated. For piers in the dam structure no significant difference in humidity occur between 5 cm and 40 cm inside the concrete. This even one of the humidity locations is located inside a house on top of a pier (no rainwater). Preliminary results of the coating systems suggest that all the systems reduce the relative humidity over time, 3 cm from the outer surface. However, more measurements and time is necessary to confirm these results. Measurements of cracks show that cracks are “alive” and expand yearly from zero to 0,25mm.

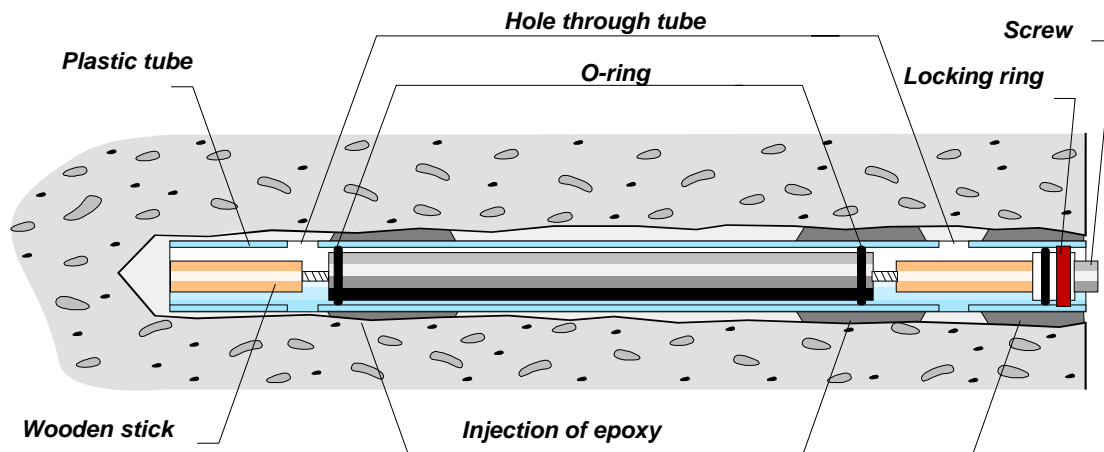
Mounting in structures -- The principle with the WS – method is humidity equilibrium between the wooden stick and the concrete. It is therefore very important that the wooden stick is not in contact with atmospheric air. In the Norwegian projects two wooden sticks (humidity profile) is mounted in a special fabricated plastic tube as shown in fig. 3.

Fig. 3: Plastic tube mounted with 2 wooden sticks. Note that the contact between concrete and plastic tube has been injected with epoxy sealers. Diameter of the tube is 20 mm.

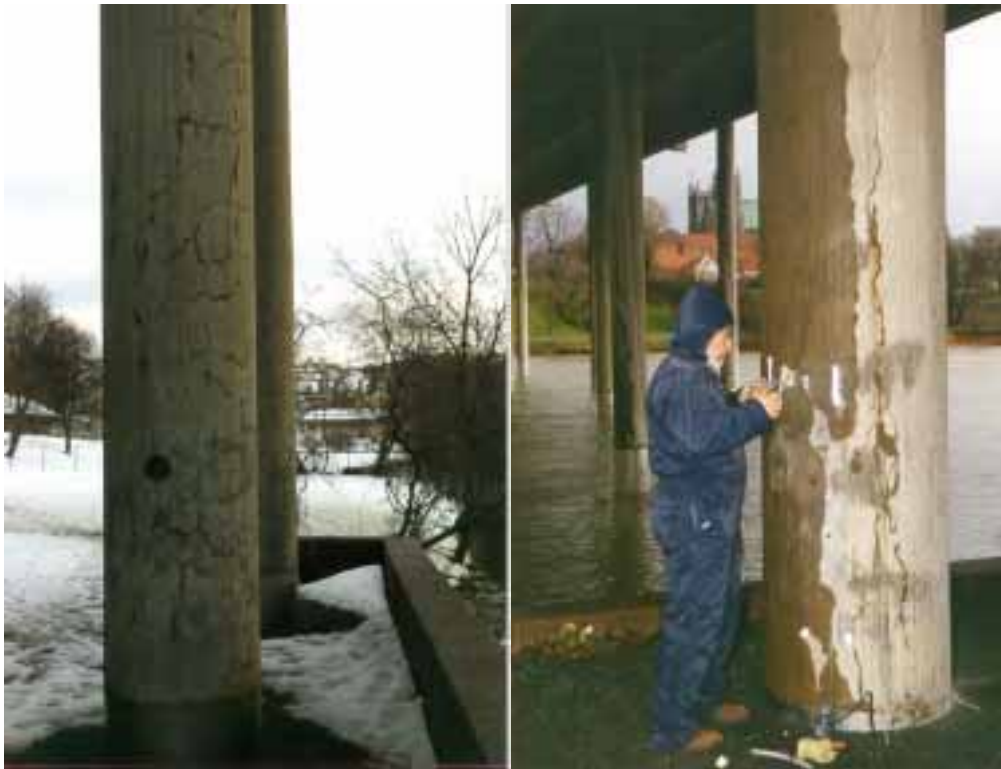
Fig.4: Map cracking and vertical cracks in columns of Elgeseter bridge. Note that the column (right photo) is wet of rainwater on western face (near the man) and dry on eastern face.

Elgeseter bridge, Trondheim – The bridge was build in 1949-1951 as a continuous 200 m long reinforced concrete beam bridge supported by 8 rows each with 4 columns with diameter of 80 cm. AAR was diagnosed in 1990 caused by the rock types mylonite, graywacke and argellite. In-situ measurements were established February 1995. In columns several verticals cracks up to 2-mm width can be followed from ground level to the underside of supported beams (10 meters). Some columns also contain map cracking, see fig. 4. Eighth measurement places have been mounted on columns/beam. Humidity by wooden sticks is measured 5 cm and 25 cm from surfaces as well as expansion of cracks, see fig. 9. Humidity profiles through 2 columns 1.2 m over ground level is established, too (western face of columns respectively eastern face), see fig. 6. Measurements of relative humidity have now been carried out for 4 years. Values are very stable with average relative humidity from 99-93 % on western faces, 5 cm and 25 cm inside the concrete and 89-87 % RH on eastern faces 5 cm from the surface.

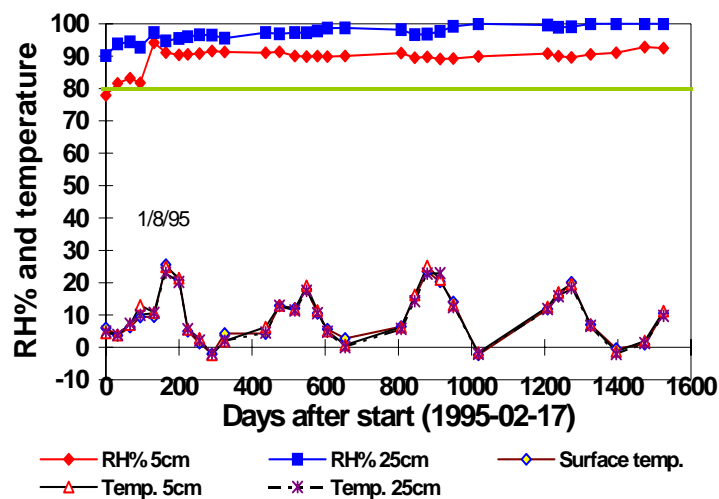
Fig. 5: Relative humidity and temperature (°C) during 4 years.

Figure 5 shows relative humidity and temperature over a 4 years period in location no. 3. Note that relative humidity is very stable over time with a slight tendency of increase

25-cm inside the concrete. In the beginning it takes some time before the wooden sticks are in equilibrium with the concrete. This because the stick was dry when inserted in the concrete. Normally it takes about 1 month before equilibrium is established because sticks now are "wetted" before inserted in the concrete. Note that temperature and yearly temperature fluctuation do not influence the relative humidity. Fig 6 shows humidity profiles through 2 columns. The profile starts from western faces, which frequently are exposed for rain. Values are average relative humidity over 4 years.

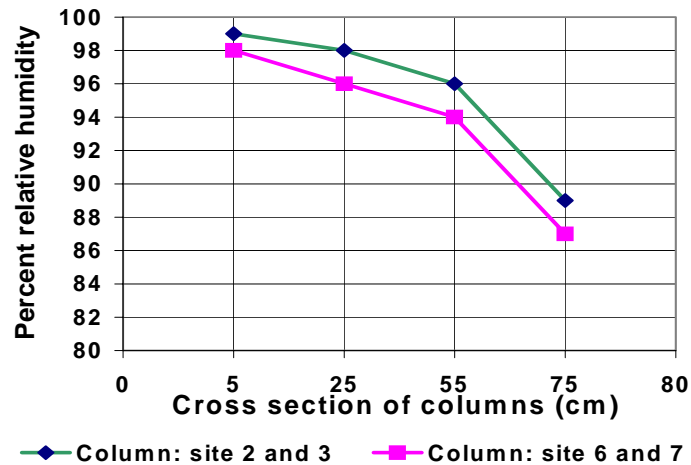
Fig. 6: Humidity profiles through 2 columns of Elgeseter Bridge starting from western faces.

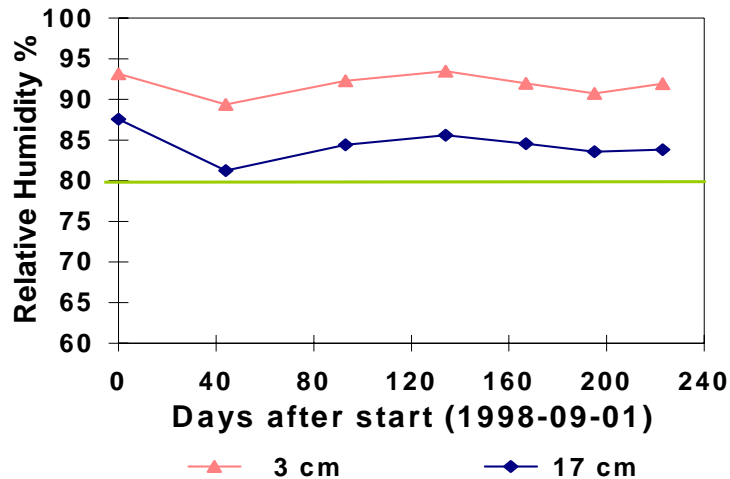
Fig. 7: Relative humidity measured 3 cm and 17 cm from outer surface in location no. 9.

systems have been applied the whole outer face of columns/beams. At writing time measurements have only been carried out 220 days and results have not been interpreted. However, preliminary results suggest that all the systems reduce the relative humidity over time, 3 cm from the outer surface.

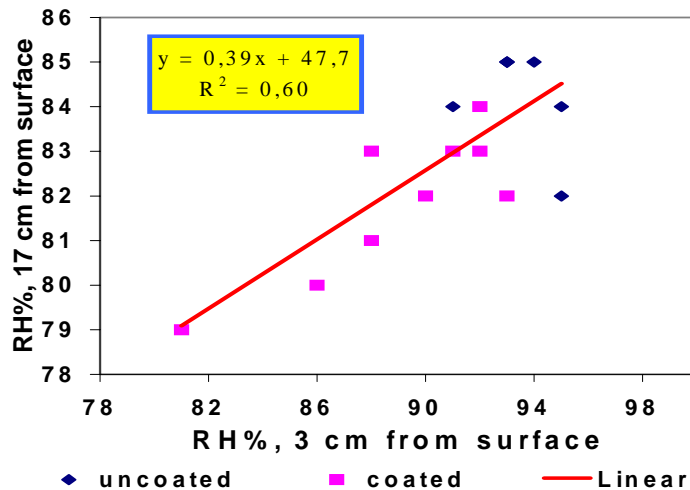
The correlation of all humidity measurements 3-cm respectively 17-cm from outer surface is shown in fig. 8. The distinct difference between coated and non-coated elements is probably accidental.

Fig. 8: Correlation of humidity measurements 3-cm respectively 17-cm from outer surface

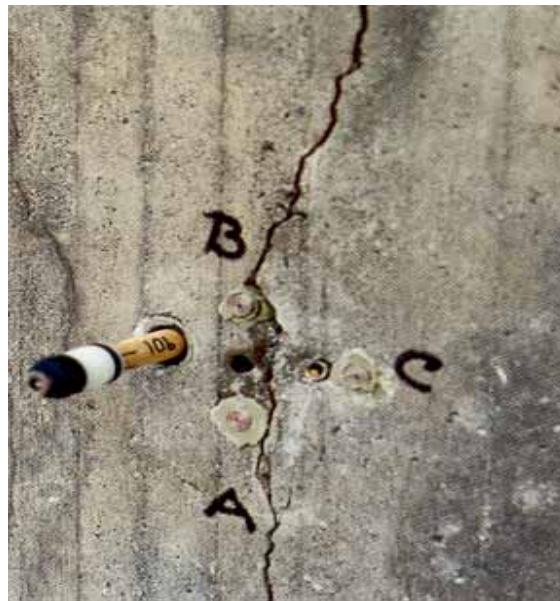
glued. Measurements along the distance A-B (always along the crack), A-C and C-B are manually measured two times by a strain gauge (Demec gauge). Calculation of expansion (opening of crack) and shear (movement parallel the crack) are carried out by a spread sheet program. All results have been corrected by use of a theoretical temperature coefficient ( $10^{-5}$  pr  $^{\circ}\text{C}$ ). Average expansion results are calculated by regression analysis. Fig. 9 shows a location (with 3 triangular arranged rosettes) for expansion measurements along a crack, and a neighboring humidity location where the wooden stick has been pulled out of the plastic tube.

Fig. 9: Location with expansion and humidity measurements, Elgeseter bridge.

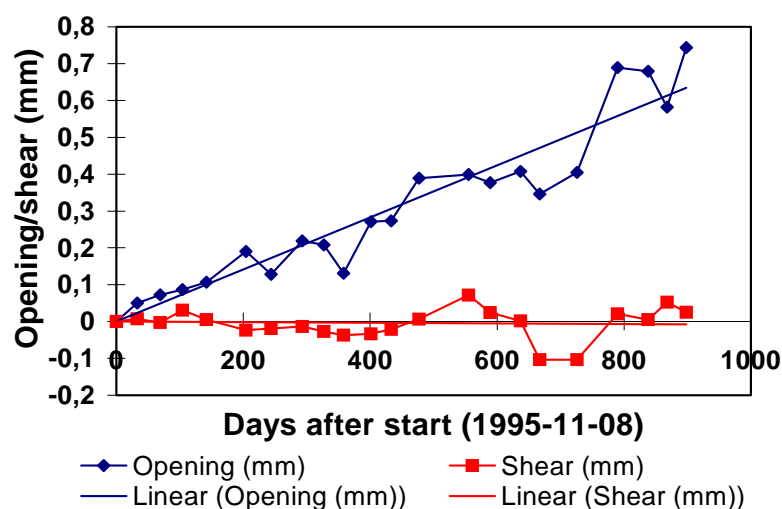
Fig. 10: Opening and shear along a crack in Dam Embretsfoss. The line is calculated from regression analysis.

The in-situ measurement system has now been in use several years in Elgeseter bridge in Trondheim and in Dam Embretsfoss, Southern Norway, both structures damaged by AAR. Up to now, measurement show that cracks are “alive” but with varying expansions. In Elgeseter bridge opening varies from 0.04mm to 0.15 mm yearly and shear from zero to 0.04 mm yearly. In Dam Embretsfoss opening varies from zero to 0.25 mm yearly and shear from zero to 0.07 mm yearly. The in-situ measurement system is now used in other Norwegian structures damaged by AAR.
